Manhole Inspection Summary

Manhole # S33EE2004MH

Location Address: **5603 PURLINGTON WAY**

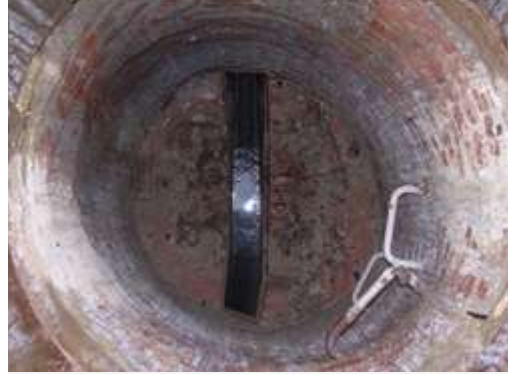
Top View

Corroded steps. Bench debris.

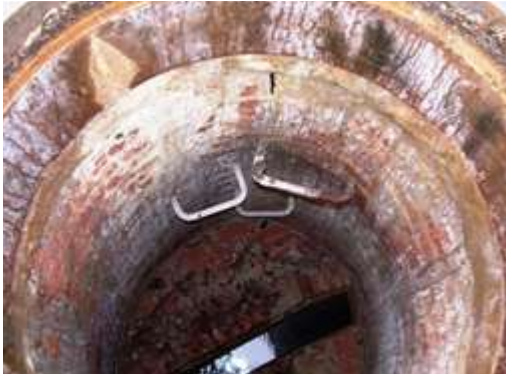
Defect

Adjustment deterioration and infiltration.
Corbel and Barrel infiltration - other side.

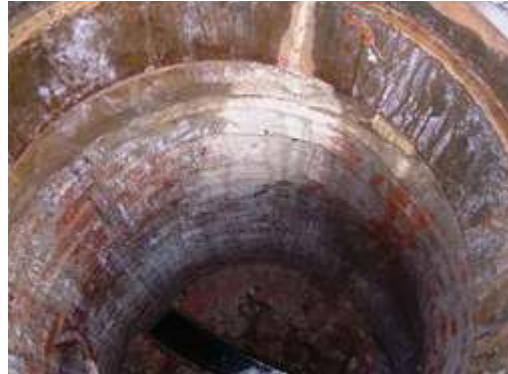
Defect

Adjustment, Corbel and Barrel infiltration.

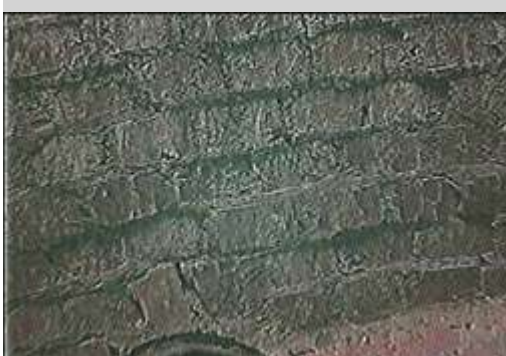
Defect

Barrel deterioration and infiltration.

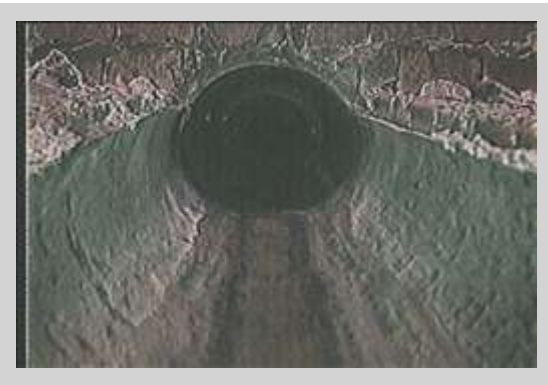
8 in. Circular Gravity Sewer Pipe Out @ 12 O'Clock

Infiltration: **Evidence** Pipe Seal Cond: **Cracked**

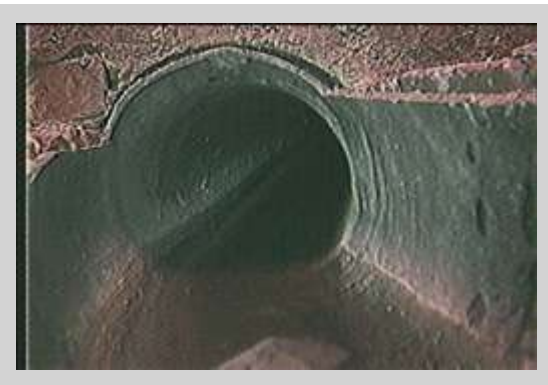
8 in. Circular Gravity Sewer Pipe In @ 6 O'Clock

Actually may come from the 7 o' clock position. The pipe bends inside.

Infiltration: **Evidence** Pipe Seal Cond: **Cracked**
